DoD Lock Program

Information Bulletin

Correction to:

“WHAT TO DO IF YOU RECEIVE A NEW CONTAINER AND THE DIAL WILL NOT SPIN” Article in the Security Facts Newsletter, Vol. 6 #2

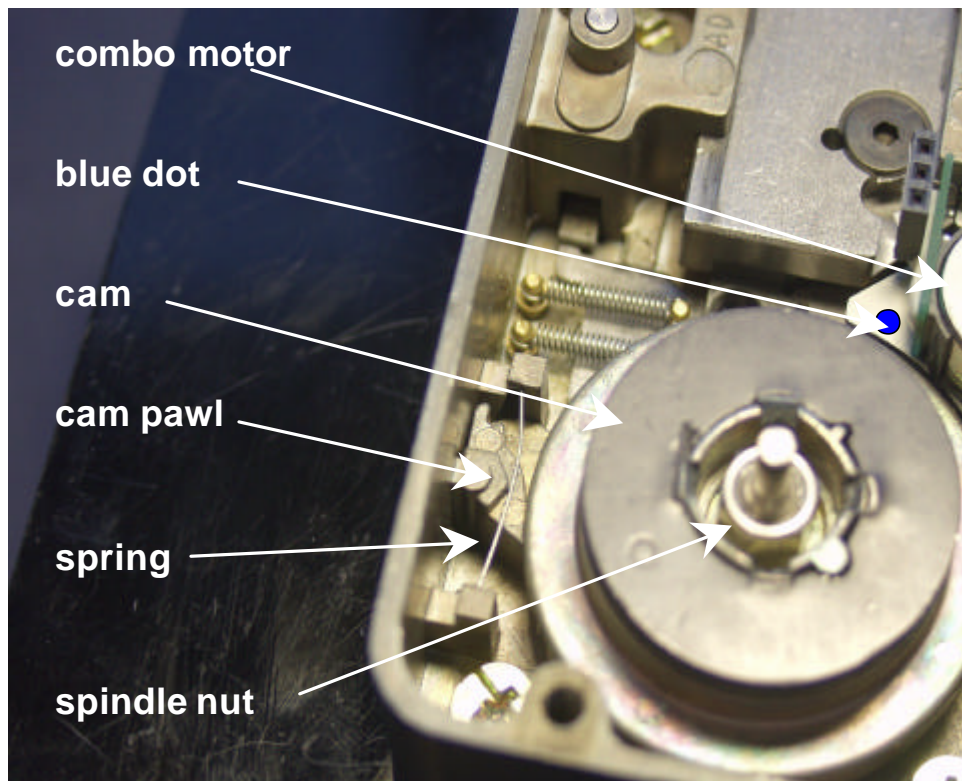
An article in the Spring 2003 issue (Vol. 6 #2, page 4) of “Security Facts” newsletter contains an error. The article dealt with removal of the cam pawl and its spring from the X09 combination lock. The photograph in the article incorrectly identified the cam pawl spring as a coil spring. THAT SPRING SHOULD NOT BE REMOVED. The cam pawl spring is correctly identified in this photograph. bulletin

Here is the correct procedure for removing the cam pawl spring and cam pawl. Holding the dial with one hand, remove the spindle nut with a 5/16” nut driver. Remove the drive cam from the spindle. Remove the cam pawl spring and the cam pawl. Replace the drive cam on the spindle. Replace the spindle nut on the spindle. Turn the drive cam so the gear teeth are near the end of the lock case (at the bottom of this photo). Brace the tip of a #1 Phillips screwdriver against the gear teeth of the drive cam to hold the cam steady as you tighten the nut.

Many of the locks that had cam pawls also had combo motors that should be replaced. (If a lock was manufactured without a cam pawl, it was made after early 2003 and its combo motor does not need to be replaced.) While you have the cover off the lock, check the combo motor. If there is not a blue dot at the location shown by the arrow, and if the lock was manufactured in 2002, the combo motor should be replaced. Contact the DoD Lock Program to obtain a replacement combo motor. Removing the existing motor and installing a new one will require a T8 Torx wrench.
