DoD Lock Program

Technical Bulletin 19-002

Internal Locking Device (ILD) Key Guide Assembly (KGA) Detent Issue

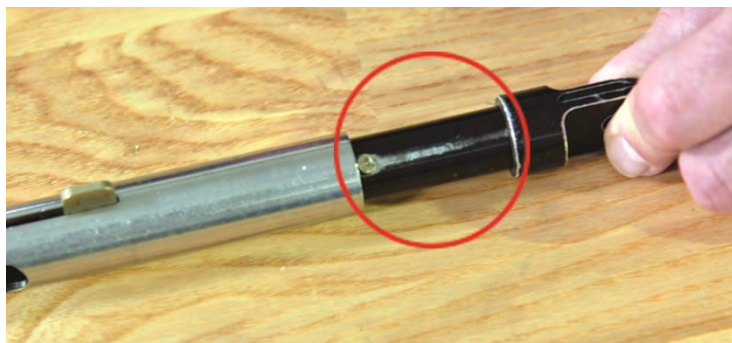
Symptom: The key guide shroud (silver tube in photos below) does not move smoothly, or the key guide shroud is stuck closed (covering the key).

Damage to key guide core.

Solution: Contact the DoD Lock Program Technical Support Hotline at (805) 982-1212, toll-free (800) 290-7607, or DSN 551-1212; or by email ILD_Field_Support@navy.mil for a replacement key guide assembly.

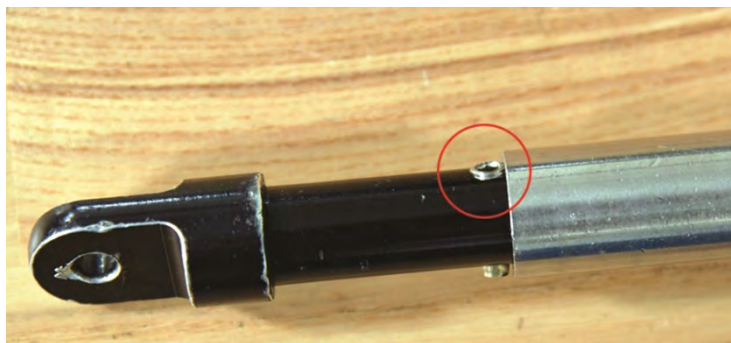
Problem: The cause is a loose detent set screw binding against the key guide shroud.

Cause is a loose detent set screw.
