# **NAVFAC OER2 Optimization Case Studies**

# ***NSF-INDIAN HEAD LANDFILL LTM OPTIMIZATION***

# ***ONIZUKA VILLAGE TREATABILITY STUDY OPTIMIZATION***

***NAVAL AIR WEAPONS STATION  
(NAWS) CHINA LAKE  
ARMITAGE FIELD OPERABLE UNIT  
FREE-PRODUCT RECOVERY SYSTEM  
OPTIMIZATION***

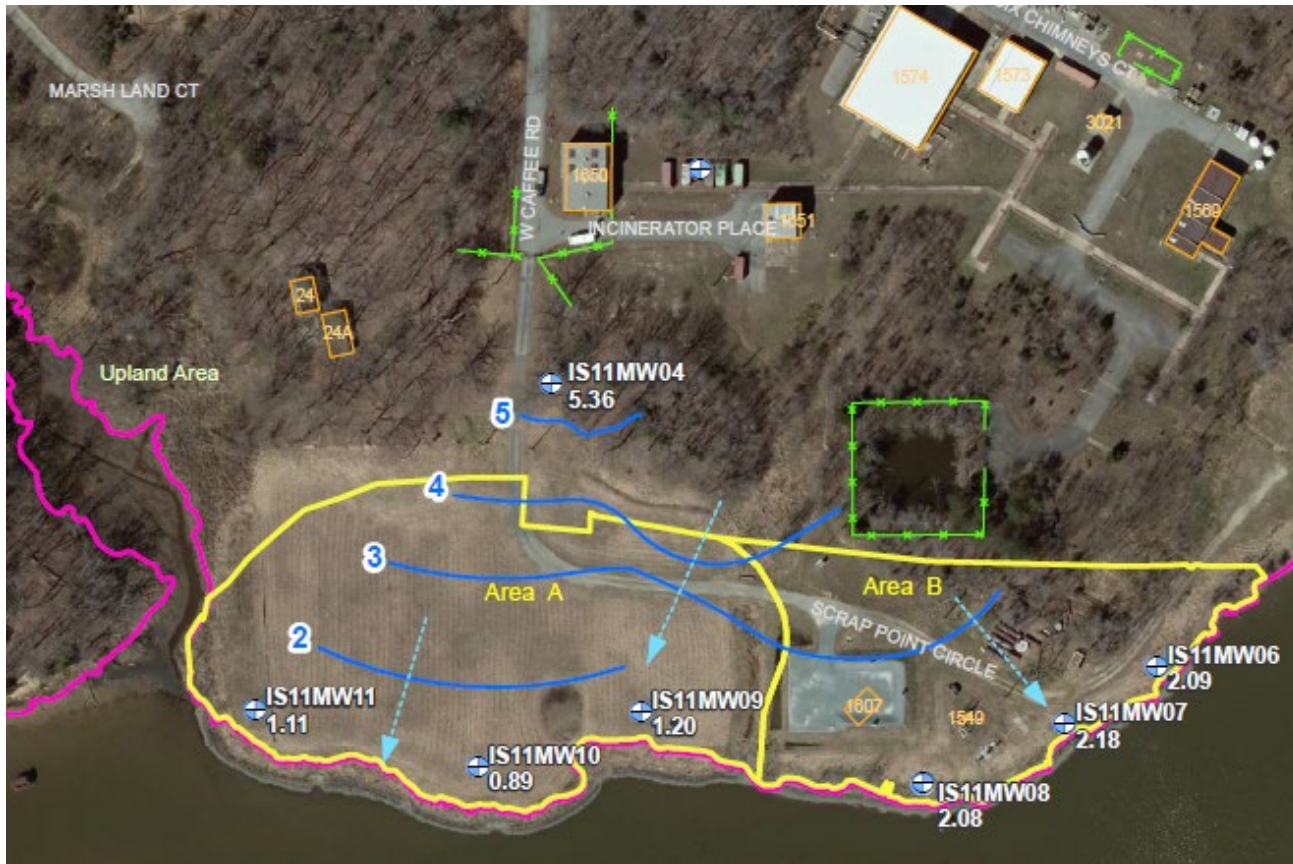
# Site 11- Caffee Road Landfill

- **7MWs - Semi-annual sample frequency**
  - IS11MW04, IS11MW06, IS11MW07, IS11MW08, IS11MW09, IS11MW10, and IS11MW11
- **No groundwater COCs per the ROD (2009)**

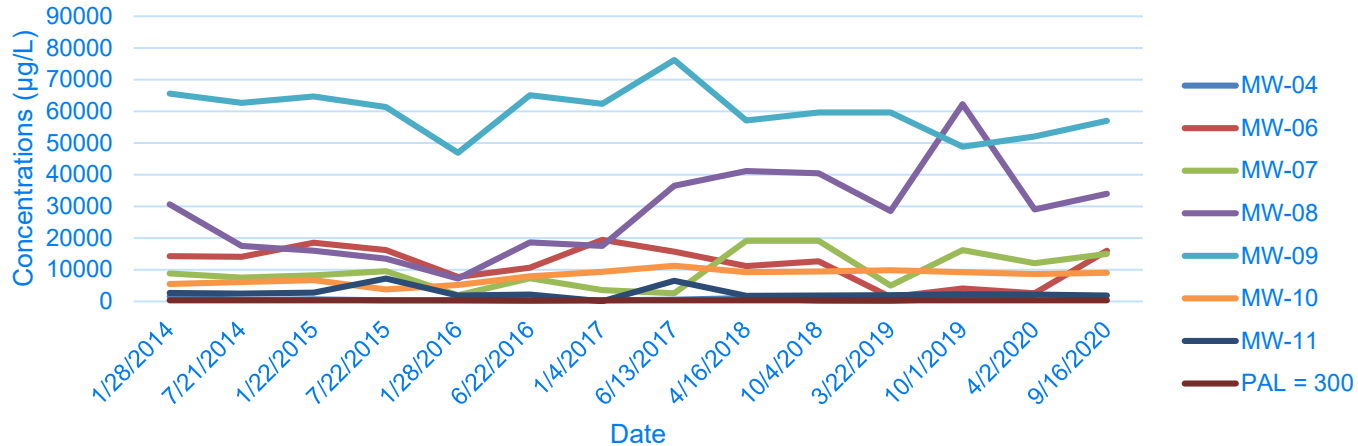
### Total Iron Concentrations

There is a close correlation between total and dissolved metals. Iron shown as an example.

- **In all wells, total and dissolved iron and manganese have exceeded the screening criteria in most rounds.**
- **Arsenic, barium, cobalt, and lead have been detected above criteria.**
- **Total and dissolved analysis typically closely match.**

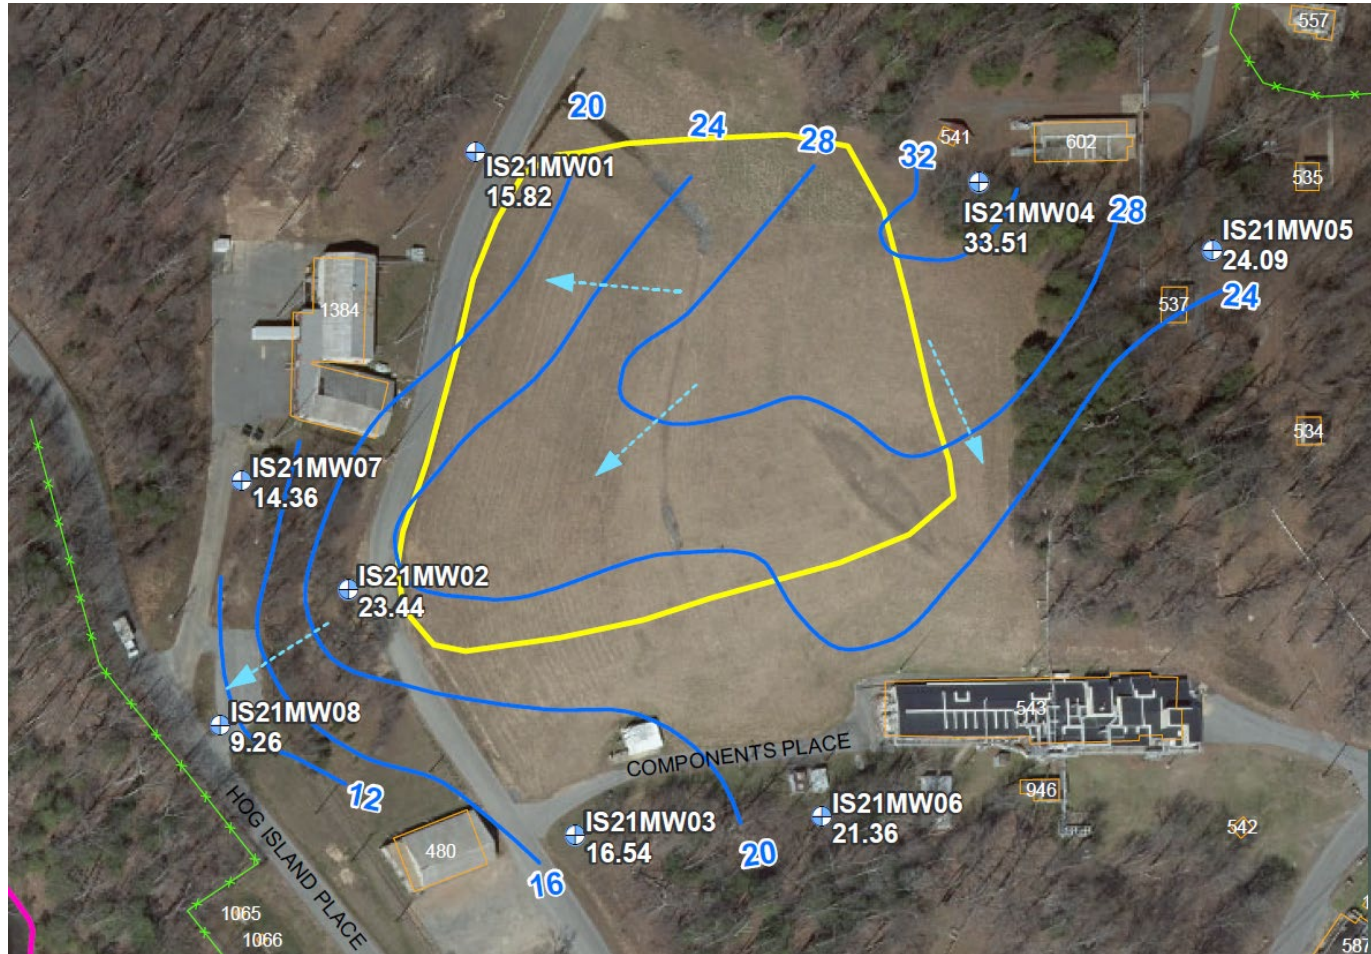
# Site 21-Bronson Road Landfill

- **8MWs - Semi-annual sample frequency**  
IS21MW01, IS21MW02, IS21MW03, IS21MW04, IS21MW05, IS21MW06, IS21MW07, and IS21MW08
- **Groundwater COC Manganese (ROD 2011)**

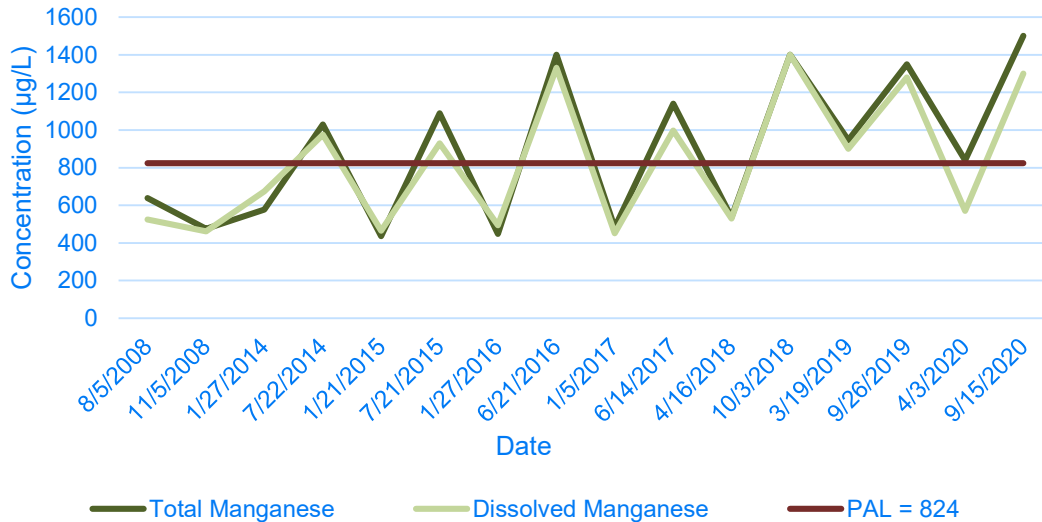
### MW-06 Manganese Concentrations

Total and dissolved analysis typically closely match. Manganese shown as an example.

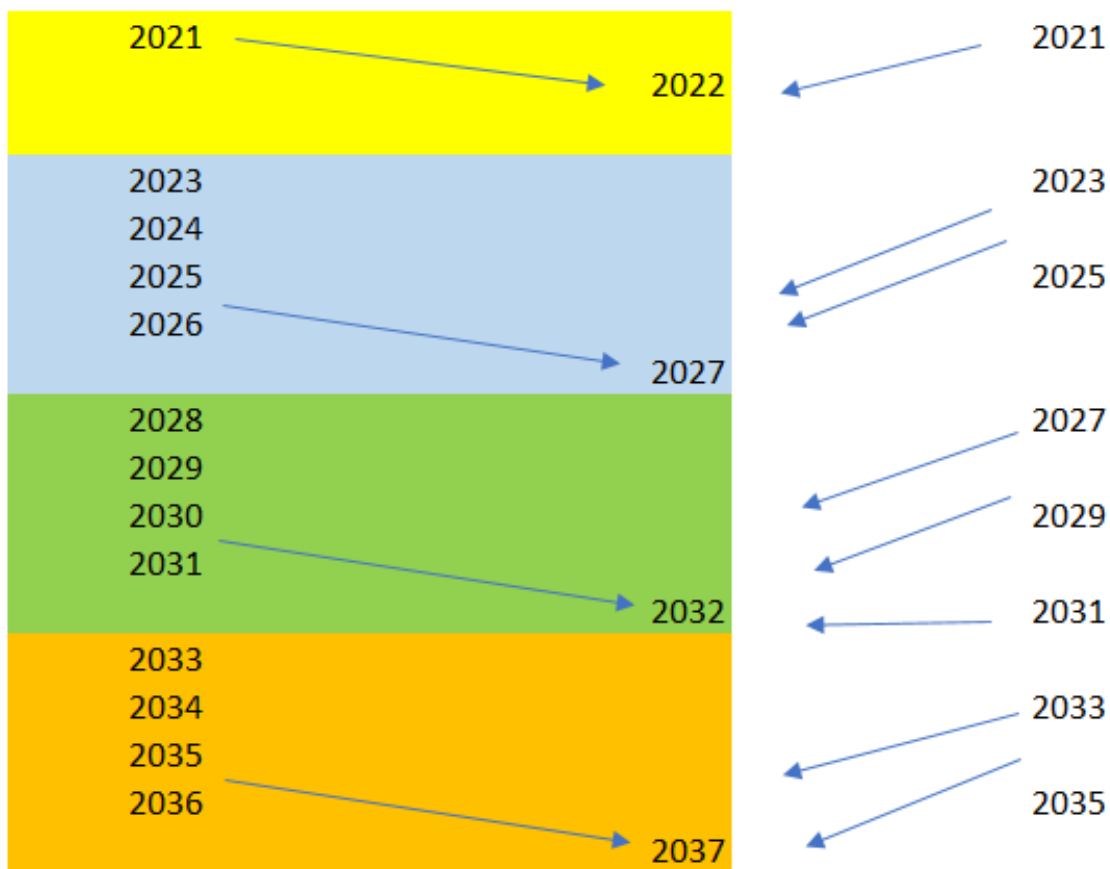
# Sampling Frequency for Sites 11 & 21

VOCs - 1x per 5YR period

Metals - biennial

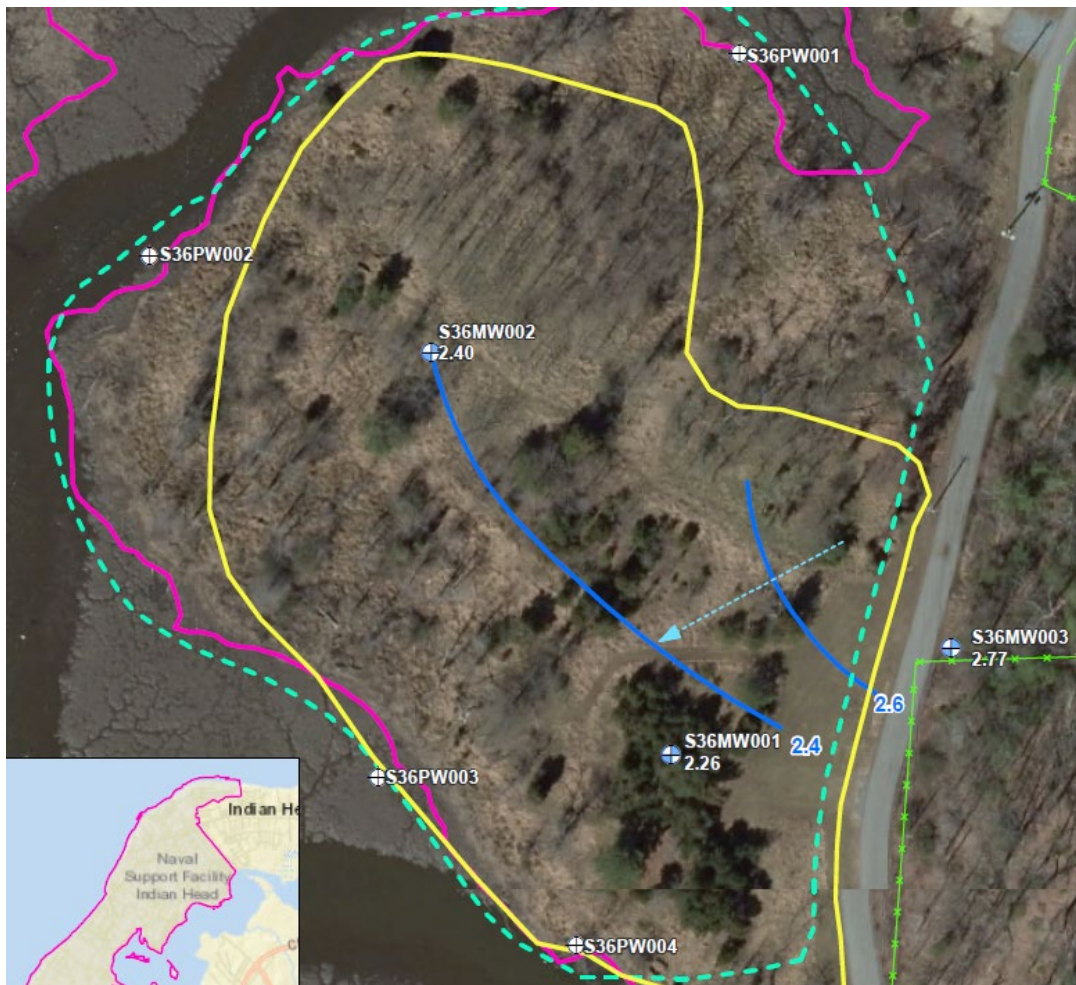
# Site 36-Closed Landfill

- **1 MW, 4 pore water sampling points - Semi-annual sample frequency**  
IS36MW03, IS36PW01, IS36PW02, IS36PW03, and IS36PW04
- **Groundwater COCs (ROD 2011): Arsenic, iron, manganese**

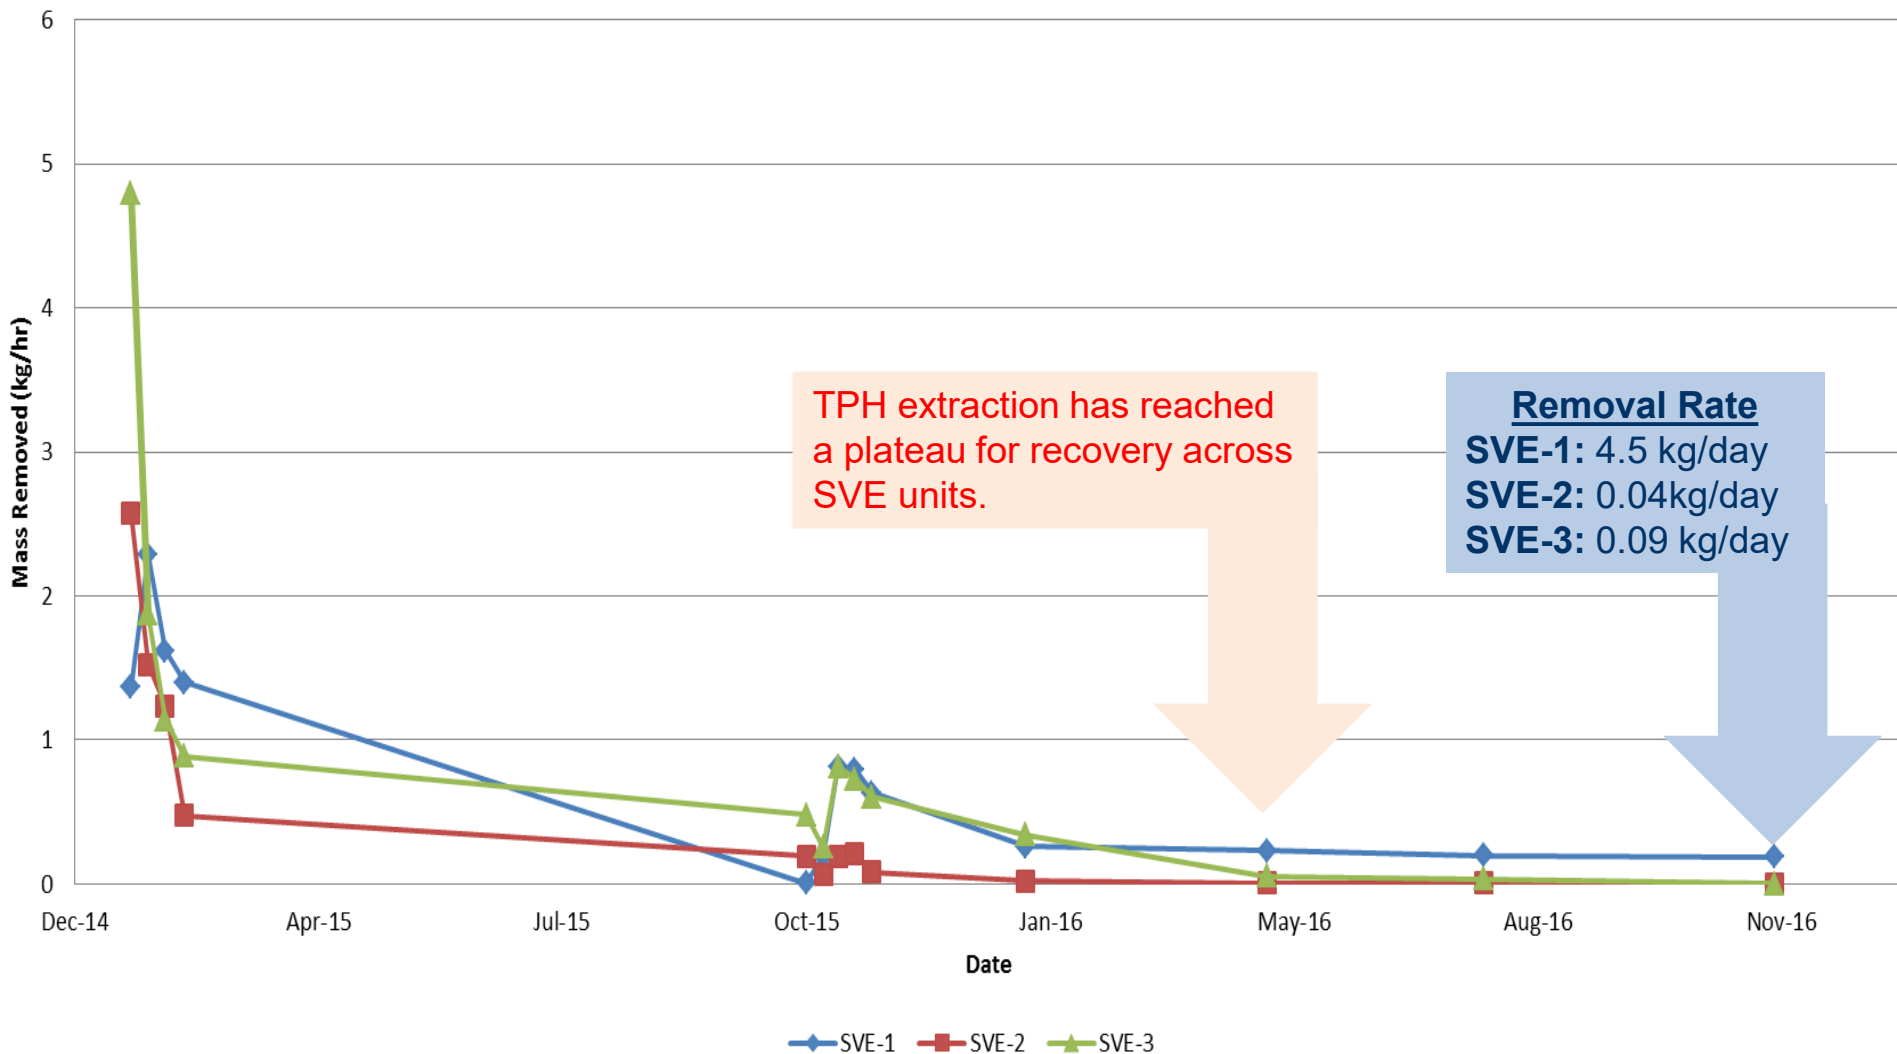
## Mass Removal Rate

Note MNA is greater than SVE removal at all locations.

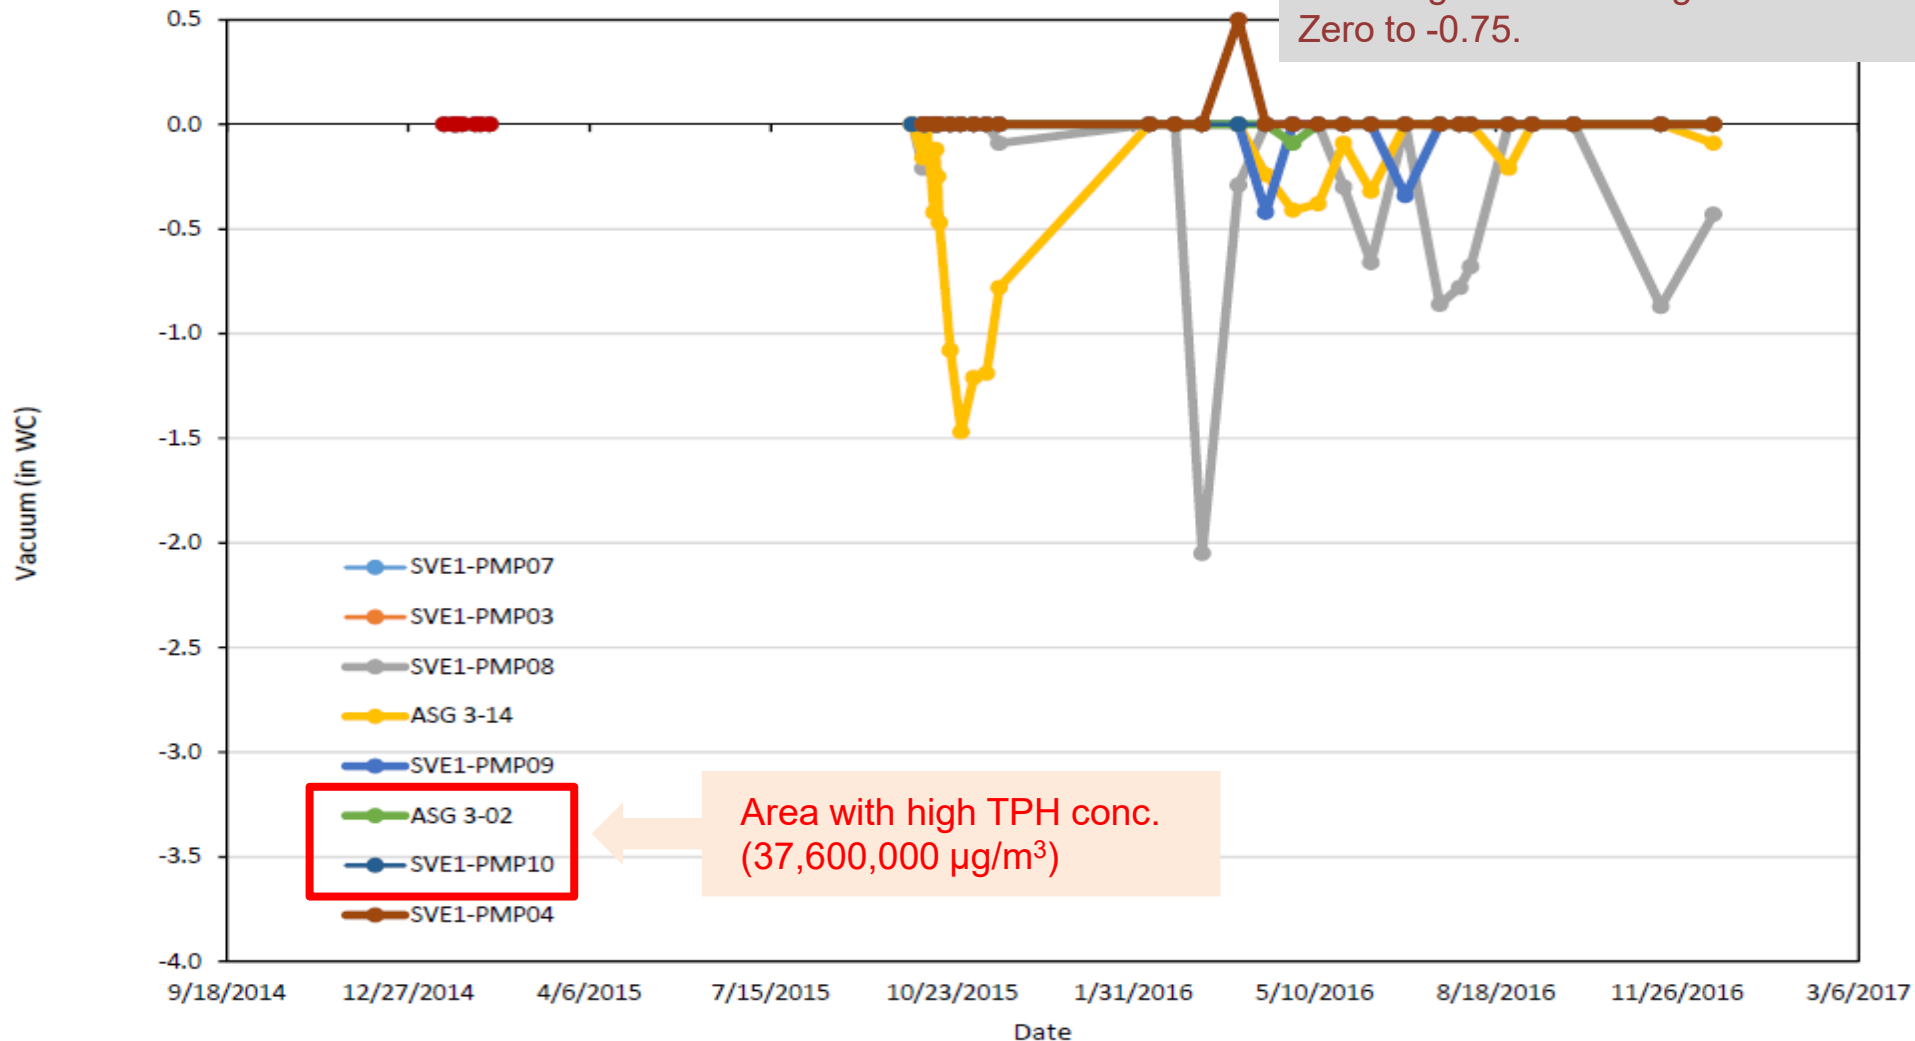
SVE-1 Distal Section Vacuum over Time

**SVE 1 After Sewer Feature**  
Note Avg Vacuum Range  
Zero to -0.75.

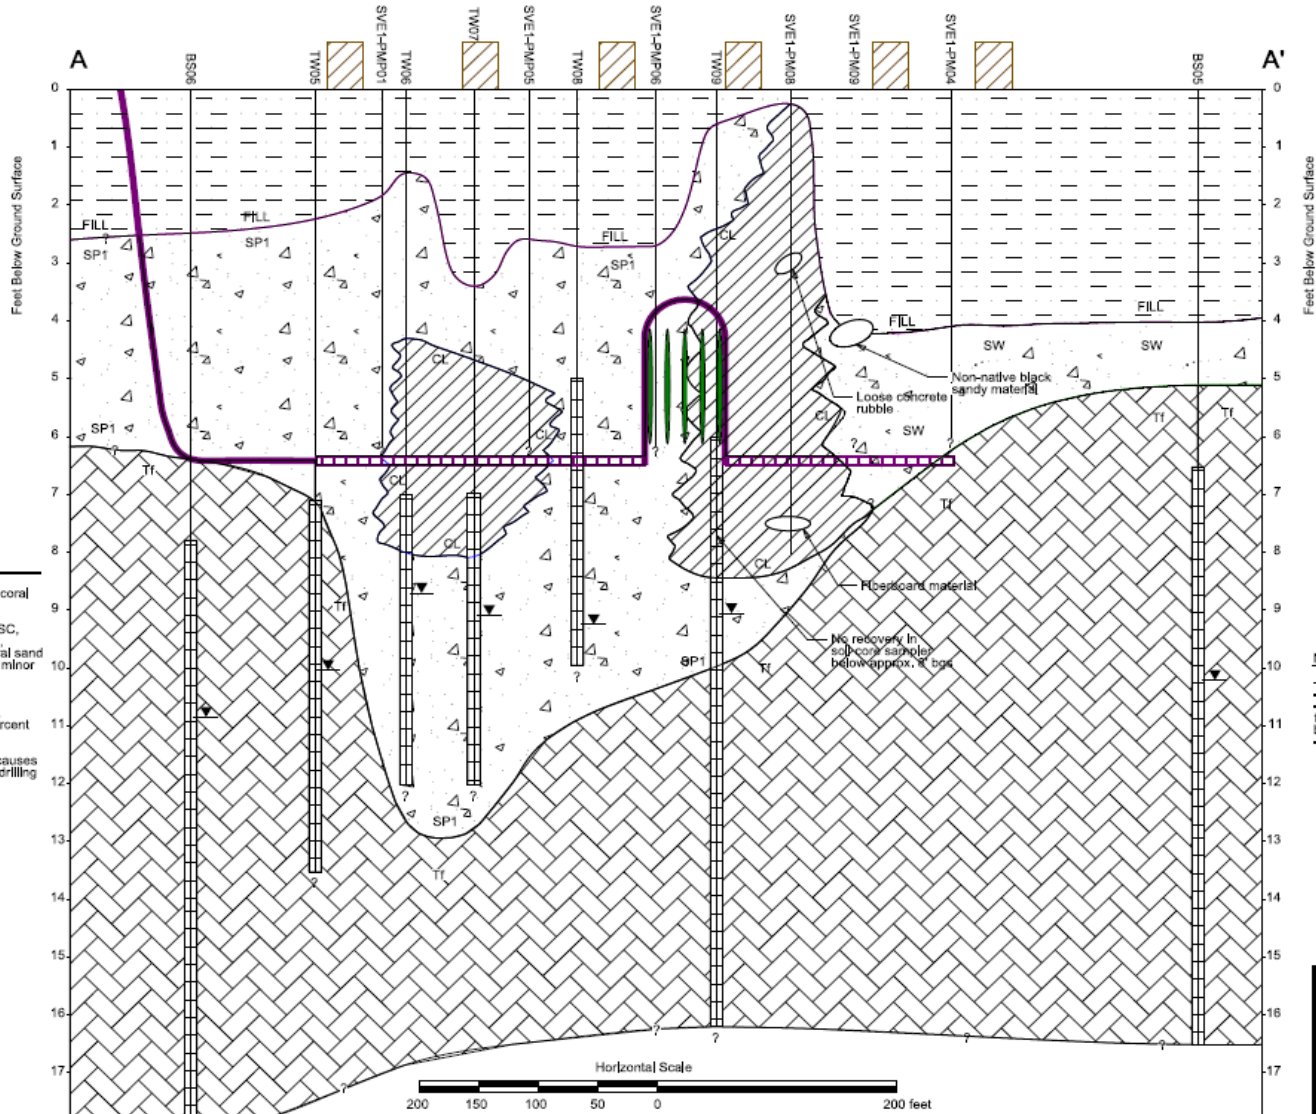
# Cross-Section SVE 1

- Notes:**
- Approximately 50x vertical exaggeration
  - Ground surface is assumed level
  - Stratigraphy is derived from field descriptions, and the soil profile between soil boring logs is interpreted based on professional judgement
  - ?? Stratigraphy is uncertain because of limited data

**Conceptual Cross Section of Horizontal Wells SVE-1 - A-A'**  
 Treatability Study Report for Subsite ST32 Onizuka Village, Joint Base Pearl Harbor-Hickam, Oahu, Hawaii

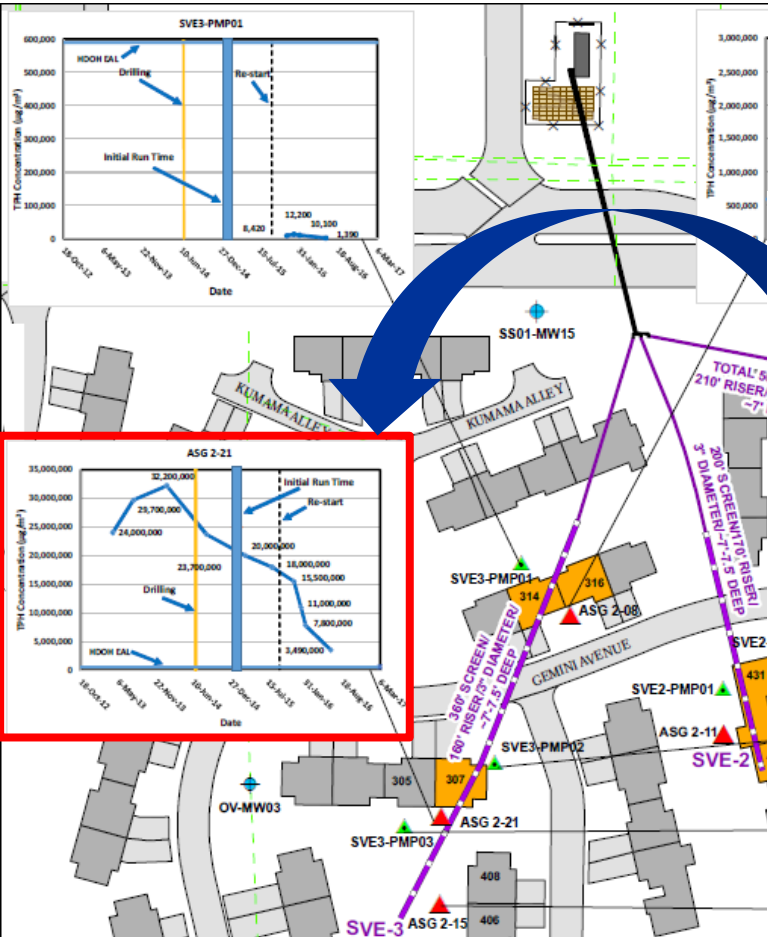
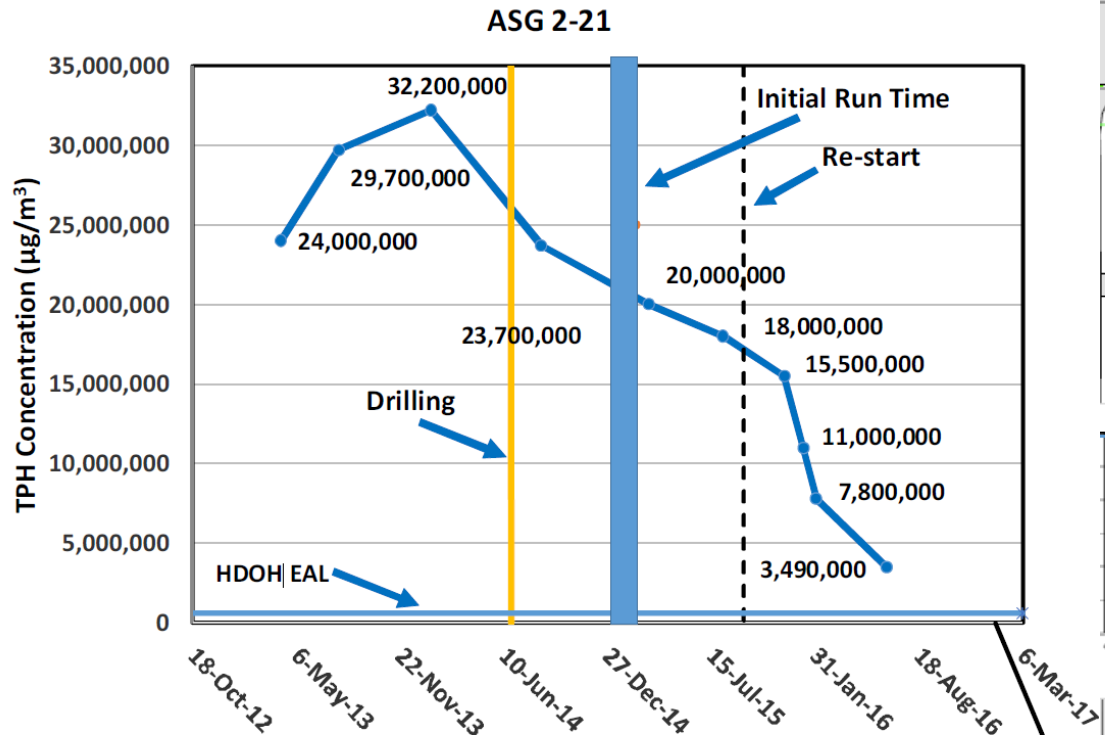
FIGURE 5-11

**Note:** ASG 2-21 exceeds HDOH EALS for TPH (3,490,000 µg/m³)

**SVE 3 TPH Concentrations**

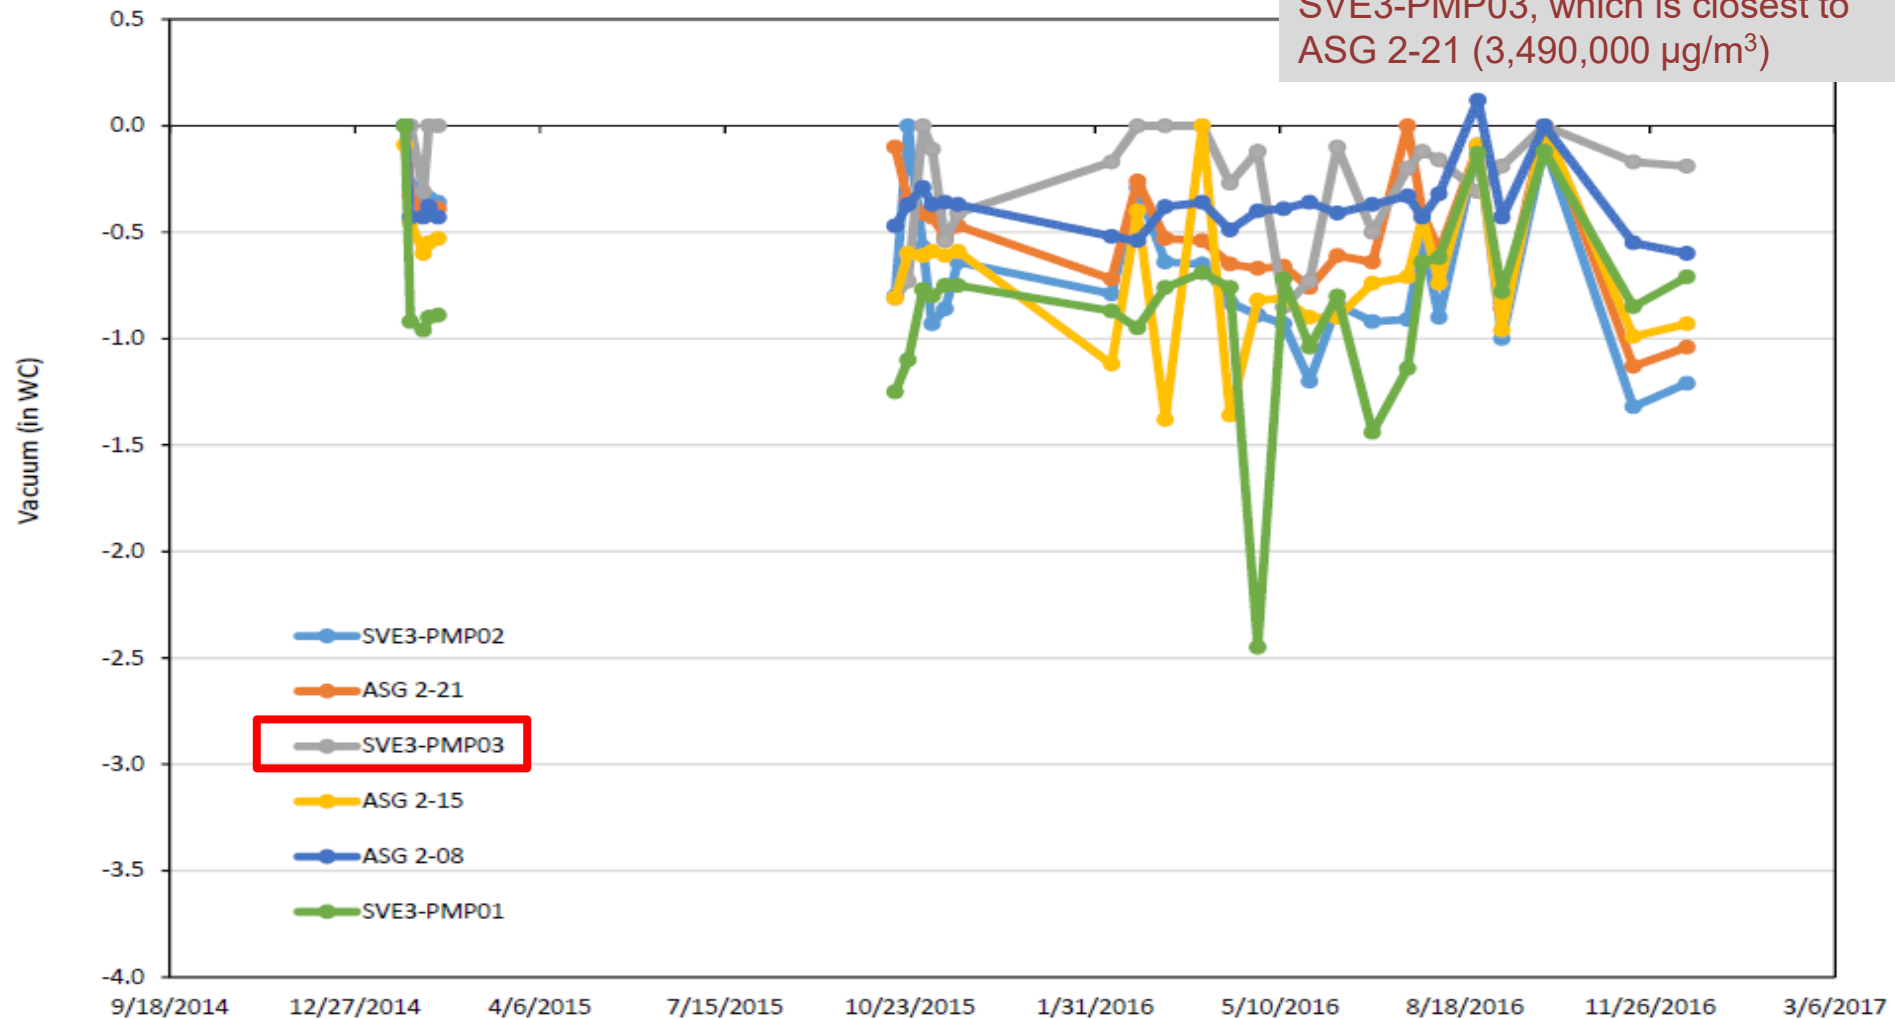
SVE-3 Vacuum over Time

**Note:** Lowest vacuum strength at SVE3-PMP03, which is closest to ASG 2-21 ( $3,490,000 \mu\text{g}/\text{m}^3$ )

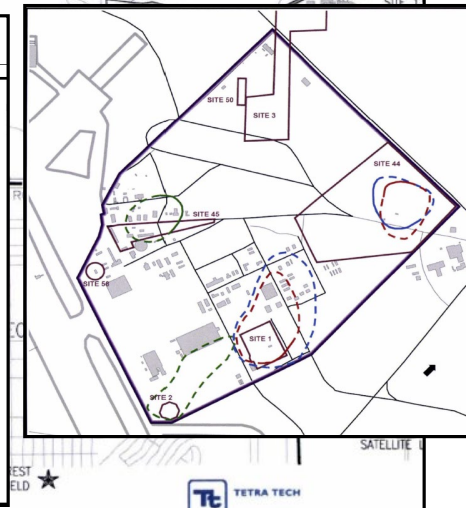
\* Remove free product to the maximum extent practicable at IRP Site 1 and 44

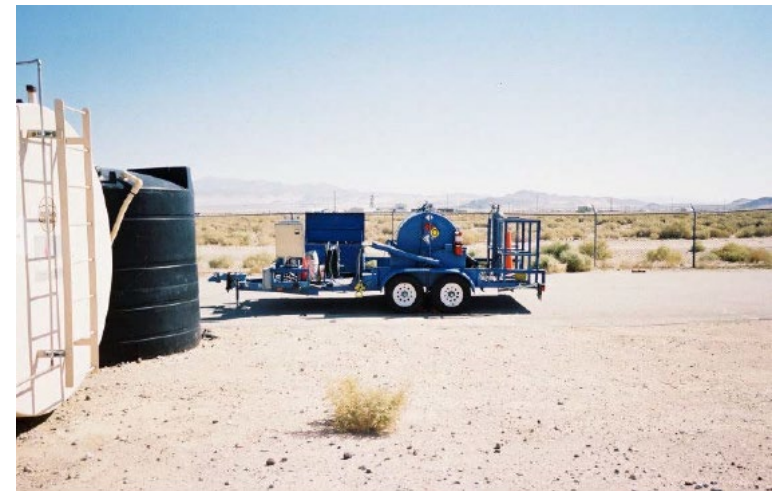
# IRP Site 1 SVE and Free Product Recovery System (FPRS) Operations (2016)

- Continued declining recovery rates of the VES and MPRS.
- All product recovery wells at IRP Site 1 have yielded <0.5 gallons per day.
- Average product removal rate for the overall vapor extraction system, ~1 pound per day.
  - ~6.0 pounds per day at EX-1
  - ~3.3 pounds per day at EX-6
  - ~2.1 pounds per day at EX-7
- Current system installed as a pilot-scale system and not designed for entire site (circa 1988).
